**FHWA/IN/JTRP-2004/24**

**JOINTLESS AND SMOOTHER BRIDGES:  
BEHAVIOR AND DESIGN OF PILES**

Joint Transportation Research Program  
Project No. C-36-56XX  
File No. 7-4-49  
SPR-2393

Conducted in Cooperation with the  
Indiana Department of Transportation  
and the Federal Highway Administration

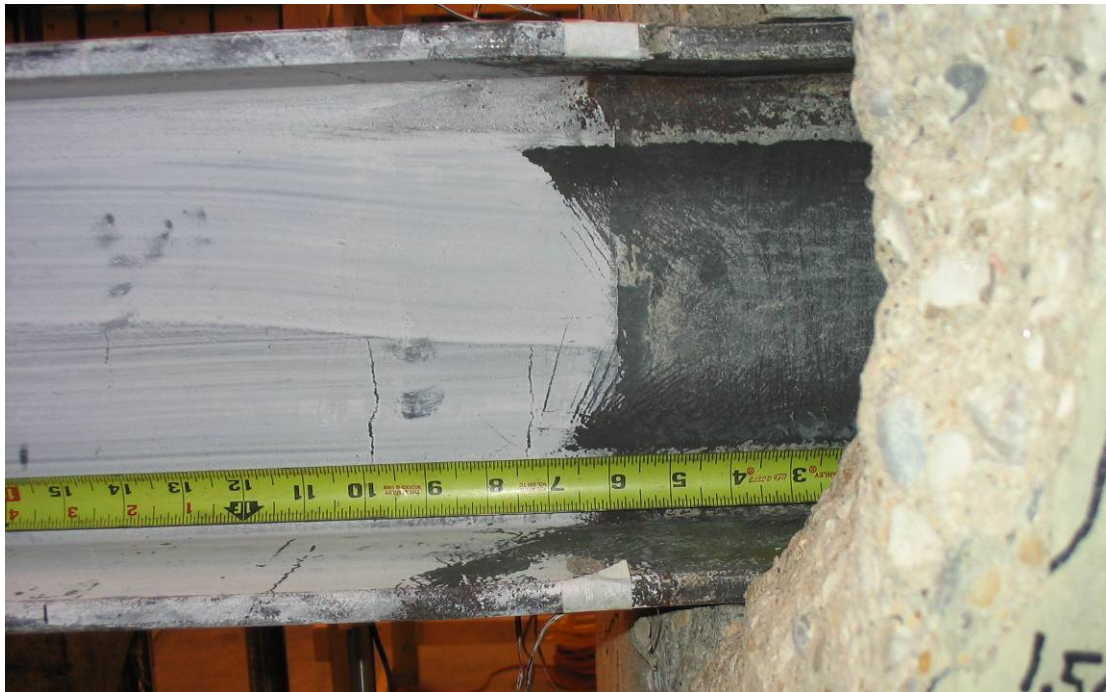
**Figure 6.21: Specimen 2 – Flange Buckling on the East Side**

Specimen 2 was the same pile size and was subjected to the same axial stress as Specimen 1. This specimen, however, was oriented for strong axis bending to evaluate the effect of pile orientation. By inspection, no yielding was observed until 0.75 in., but strain gages on the flanges indicated yielding of the NW and SW flanges in the 0.50 in. displacement range. Yielding of all flanges was evident and pull-out cracks on the concrete abutment were noted as early as the 0.75 in. displacement range. Pinching of the lateral load-deflection response was evident as early as the 1.00 in. displacement range. The pinching could be attributed to the deterioration of the concrete at the connection. The NW and SW flanges started buckling during the displacement range of 1.50 in. and all flanges buckled during the 1.75 in. displacement range. Figure 6.21 shows buckling of the NE and SE flanges along with deterioration at the abutment-pile connection.
